UNDERWATER BRIDGE INSPECTION REPORT

STRUCTURE NO. 73540

10TH STREET BRIDGE (MSAS NO. 101)

MINNESOTA DEPARTMENT OF TRANSPORTATION
UNDERWATER BRIDGE INSPECTION

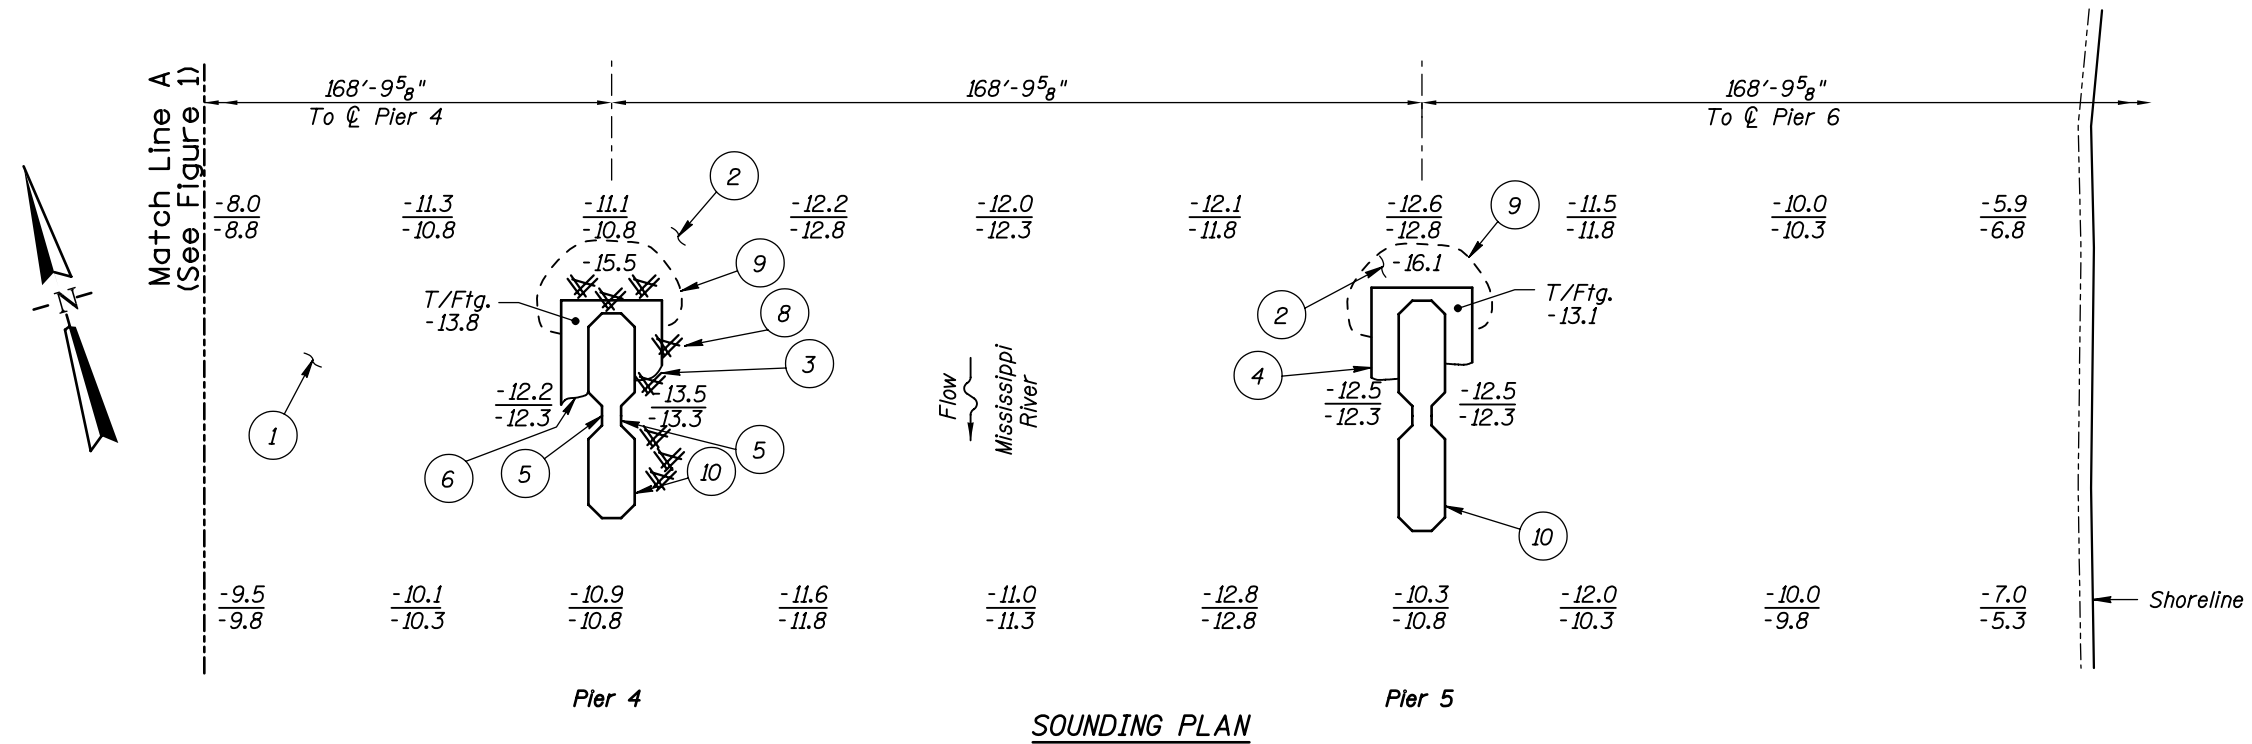
Date: SEPT. 2002
Scale: NTS
Figure No.: 2

- 1 The channel bottom material consisted of sandy gravel and random cobbles with a maximum probe rod penetration of 2 inches.
- 2 The channel bottom material consisted of loose sand with a maximum probe rod penetration of 2 feet at the upstream end of Piers 4 and 5.

- 3 Footing exposure was observed at the upstream end of Pier 4, extending 20 feet downstream on the west side of the pier and 18 feet downstream on the east side, with a maximum vertical face exposure of 2 feet at the upstream nose.

- 4 Footing exposure was observed at the upstream end of Pier 5, extending 8 feet downstream on both sides of the pier, with a maximum vertical face exposure of 3 feet at the upstream nose.

- 5 A vertical crack was observed along the centerline of the pier extending from 3 feet below the waterline to the top of the web wall with a 1/4 inch maximum width.

- 6 A crack was observed on the top of the west side of the footing extending to the center of the pier face with a maximum width of 1/4 inch.
- 7 A moderate accumulation of 18-inch-diameter and smaller timber debris was observed at the upstream end of Piers 2 and 3 extending from 5 feet below the waterline to the channel bottom.

- 8 A light accumulation of 2-inch-diameter and smaller timber debris was observed at the upstream end and along the east face of Pier 4.
- 9 Minor scour depressions, typically 5 foot in radius and 2 to 3 feet deep, were observed around the upstream ends of all the piers, resulting in footing exposure at Piers 4 and 5.

- 10 The submerged concrete of the piers and exposed footings was in good, smooth and sound condition.
